**Addendum Revision 1 to the
Response Action Work Plan
Troy High School Removal Plan**

116 East Missoula Avenue

Troy, Montana

March 15, 2006

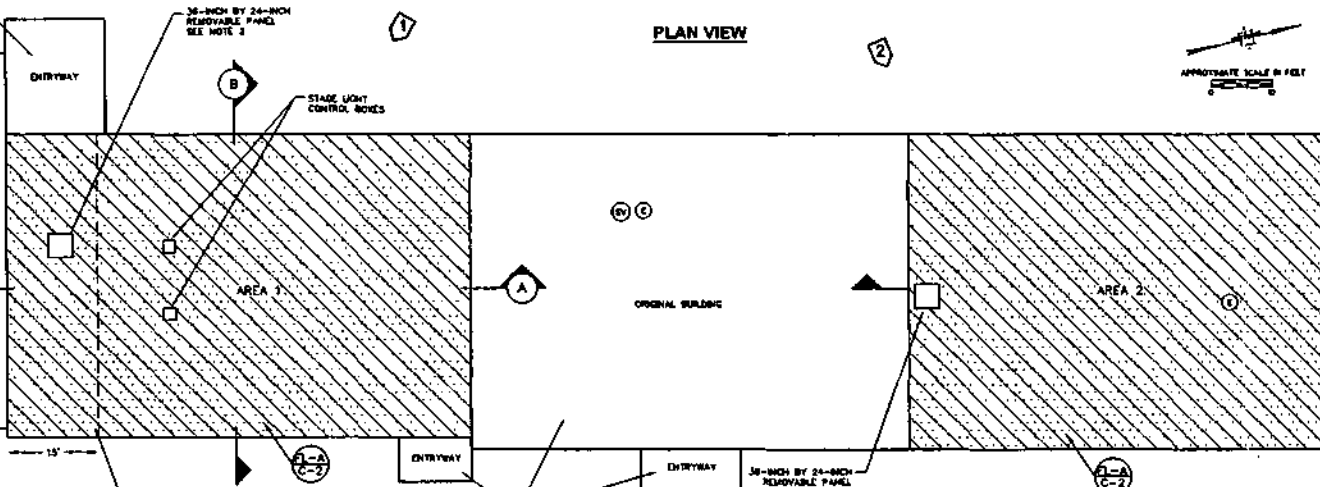
ENTRYWAY DOES NOT CONTAIN VERMICULITE INSULATION AND DOES NOT SHARE AIRSPACE WITH AREA 1. REMEDIATION IS NOT REQUIRED.

SOUTH ADDITION DOES NOT CONTAIN VERMICULITE INSULATION AND DOES NOT SHARE AIRSPACE WITH AREA 1. REMEDIATION IS NOT REQUIRED.

1. DRYWALL AN 18-INCH BY 18-INCH OR EQUIVALENT AREA IS MAINTAINED AT THE ATTIC ACCESS FREE OF OBSTACLES FOR THE INGRESS AND EGRESS OF PERSONNEL.
2. CONSTRUCT SCAFFOLDING TO ACCESS AREAS 1 AND 2. THE ACCESS TO AREA 1 IS LOCATED 15-FEET ABOVE THE STAGE. THE AREA 2 ACCESS IS LOCATED 8-FEET ABOVE THE FLOOR.

4. REMOVE, TRANSPORT, AND DISPOSE OF ALL INSULATION FROM THE ATTIC.
5. BUILD CONTAINMENT THAT ENCOMPASSES AT A MINIMUM THE 15-FOOT BY 53-FOOT STAGE BENEATH THE SOUTH END OF AREA 1. REMOVE AND PROPERLY DISPOSE OF CEILING TILES ABOVE THE STAGE.

6. PERFORM AN INTERIOR CLEANING OF THE CONTAINED AREA. RESTORE THE CEILING WITH 5/8-INCH SHEETROCK FINISHED WITH ONE COAT OF WHITE PAINT.
7. ALLOW TWO DAYS AFTER REMEDIAL ACTIVITIES FOR MAINTENANCE TECHNICIANS TO PERFORM ELECTRICAL INSPECTION AND NECESSARY REPAIRS AND/OR UPDATES.

8. INSTALL BLOW-IN INSULATION IN AREAS 1 AND 2, AND RESTORE ALL AFFECTED ATTIC AREAS. THE INSTALLED INSULATION WILL BE SUFFICIENT TO MEET THE CALCULATED CEILING RATING OF R-36 IN AREA 1, AND R-52 IN AREA 2.
